## Part No: 1ED3122MU12HXUMA1

In our application, -40kV is switched using 40 Nos of MOSFETs which are connected in series connection (Refer Fig). 40KV isolation is provided between each 1kV switching module and the controller module using isolation transformers. Each MOSFET's gate will be driven by the gate driver IC **1ED3122MU12HXUMA1**. VCC1 (+5V) and VCC2 (+20V) supplies of Gate driver IC are isolated supplies. The gate driver and MOSFET are connected as shown in the Figure 1 & Figure 2.

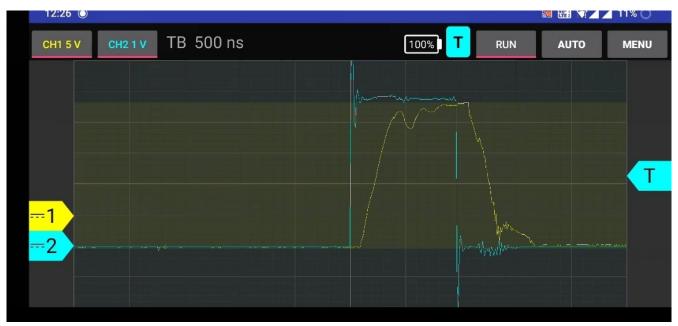
**Figure 3**: Gate to source Voltage(CH1 - Yellow) with respect to the IN+(CH2 - Blue) during normal condition

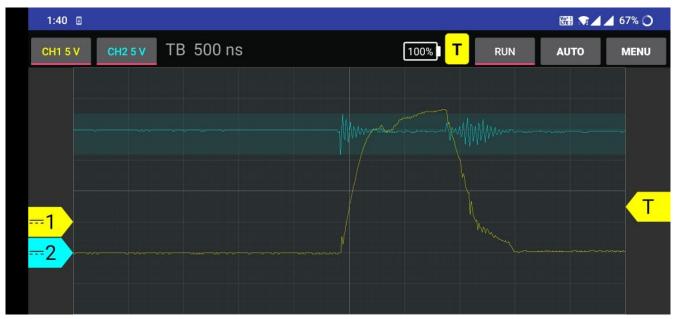
**Figure 5**: Gate to source Voltage(CH1) with respect to the VCC2(CH2) during normal condition

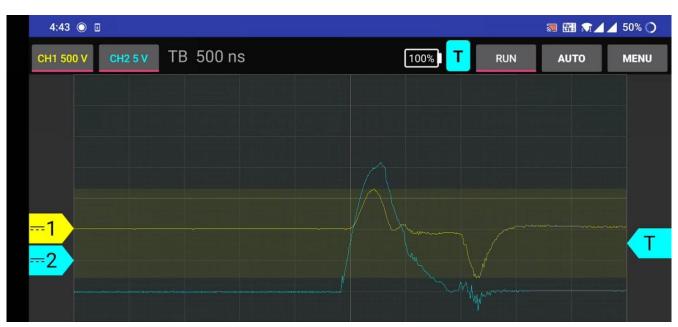
**Figure 8 :** Gate to source Voltage(CH2) & Voltage across GND1 & VEE2 capacitor ground(CH2) at false turn off condition

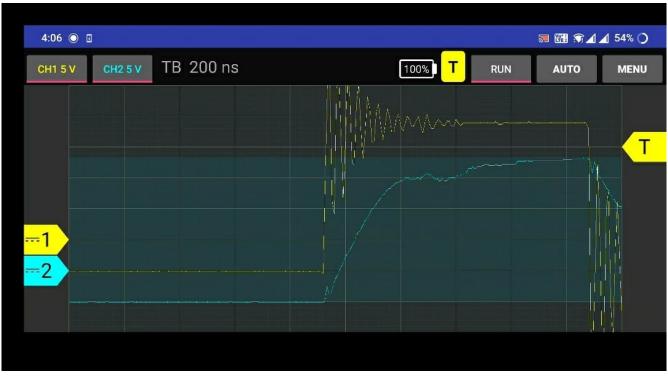
While switching the -40kV with 1us pulse width at 1Hz, the 39th MOSFET was observed as a false turn OFF at the driver output. In this scenario, input of the gate driver was normal with 1us pulse width, but the gate driver output was abnormal which means it was turned off approximately 300ns instead of 1us as shown in Figure 9 & Figure 10.

**Figure 9**: Gate to source Voltage(CH2) with respect to the gate driver output(CH1) at normal condition

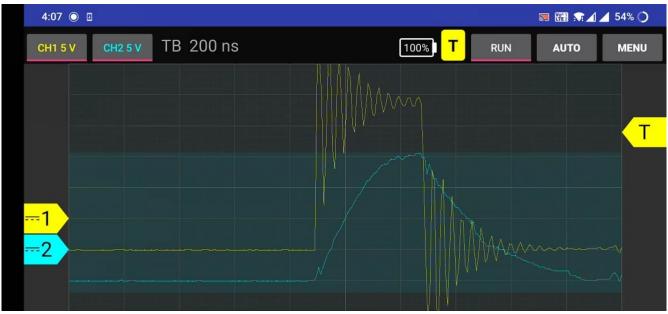
- **IN+** was measured and found OK as mentioned above.
- **IN-** pin is shorted to ground using 0 Ohm resistor.
- VCC1 and VCC2 were measured and found OK.
- **CLAMP** pin was measured at the time of false turn OFF, as it was directly short with the MOSFET gate terminal, the same wave form observed in the clamp pin.
- 2x 512 Ohms connected across SGND1 & PGND1 to limit the voltage built up between primary and secondary of gate driver IC. The voltage across the 2x 512 Ohms was measured as 700V during MOSFET switching.
- OUT pin was measured and found that it was turned OFF approximately 300ns instead
  of 1us.

**Figure 10**: Gate to source Voltage(CH2) with respect to the gate driver output(CH1) at false turn off condition
